Subject Franna Crane service and recertification

The crane detailed below has recertly under gone a 10 year inspection and recertification Social State of the state of th In accordance with the requirements of the Australian Standards As 1418 part 5 and As 2550 part 5.

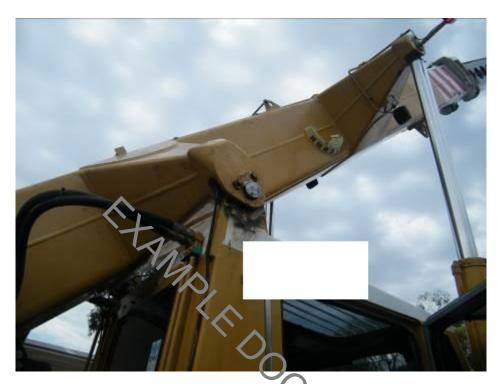
View of the boom pivot with new pins and bushes.

New Pivot pins for the boom and the luffing cylinders were fitted.

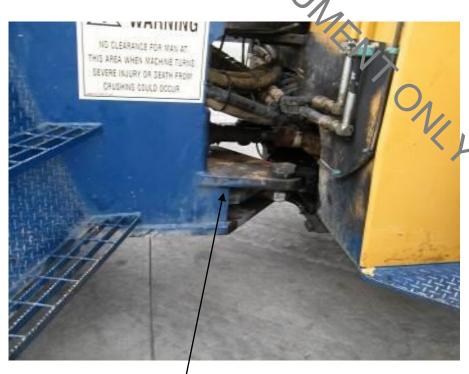
New articulation pins and bushes replaced.

Steering hydraulic cylinders serviced.

The condition of the articulation pivot was within manufacturers specifications.

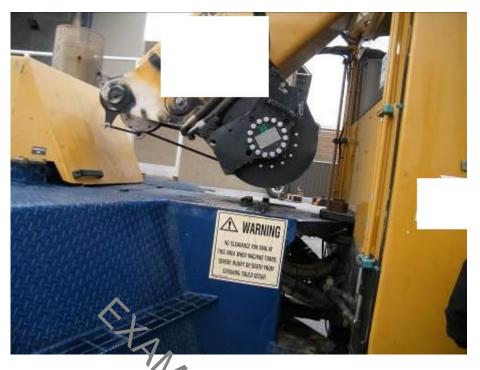
The winch assembly was serviced and the wire rope replaced.

The luffing cylinders were removed and serviced.

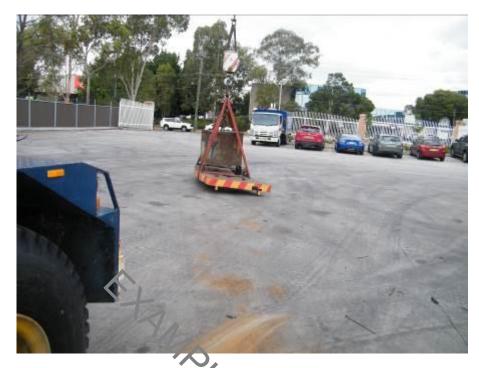
View of the load and stability testing

Full load test SWL 3.70. tonnes at a boom length of 13.8 meters.

Test load 4.7 tonnes

Line pull winch brake test SWL 4.2 tonnes.

Test Load 4.620 tonnes.
